CERL Technical Report 99/91 November 1999

# High Temperature Hot Water Generator Safety Valve Research at Wright-Patterson AFB, OH

**Investigation of Chronic Safety Valve Leaks**

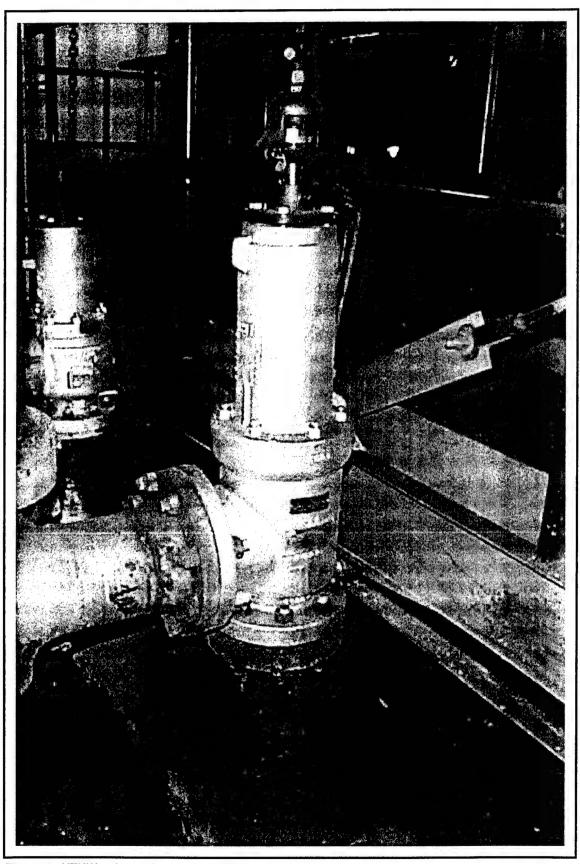
CERL and SAI conducted a site visit to WPAFB Plant 1240 on 22 December 1998. During the site visit, the investigation team examined the installed safety valves (Figure 1), reviewed plant drawings, recorded plant conditions, and interviewed plant staff. The team observed that the installed safety valves were not marked as the type required by the American Society of Mechanical Engineers (ASME) Boiler and Pressure Vessel Code (ASME BPVC) Section I Part PG-110. ASME BPVC requires fired pressure vessels to be protected with "V" stamped safety valves. Additionally, the legibility of the valve data was poor. Table 1 lists the seven items required to appear on the name plate or etched on the valve body.

Two valves are required on each of the four HTHW units, for a total of eight safety valves. Only two of the installed valves had "V" stamps. One additional valve may have had a "V" stamp, but it was hidden from view by the HTHW generator piping. Three valves had "UV" stamps. "UV" valves are not permitted on fired pressure vessels built and operated as ASME BPVC Section I systems. Two valves had neither "V" nor "UV" stamps. Appendix A to this report tabulates the legible data collected as part of this inspection.

Figure 1. HTHW safety valves in Bldg 1240.

Based on the code requirements and the available information, the team recommends that two "V" safety valves be installed on each HTHW unit. These valves should be sized to relieve the full HTHW unit capacity at 6 percent of the maximum allowable working pressure (MAWP) of 500 psig.

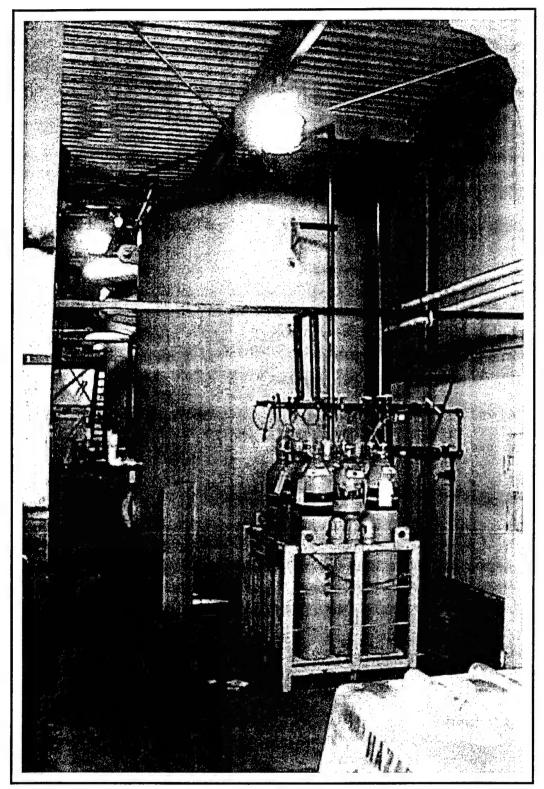
The team also recommends further investigation of how to most effectively control plant pressure during large temperature excursions. The team concurs with the plant practice of limiting operating pressure to no more than 440 psig. It may prove helpful to improve the controls on the  $N_2$  expansion tanks by adding or removing water to control pressure, in addition to adding level control for water inventory. Another option would be to increase expansion tankage so that a given level change would reflect a much smaller pressure swing.

Figure 2. Nitrogen (N<sub>2</sub>) expansion tanks.

Plant 1240 has a computerized plant data recording system that is useful for investigating plant upsets. Unfortunately, system pressure is not recorded as a trend. It is recommended that the screen interface be modified to trend plant pressure and nitrogen  $(N_2)$  expansion tank level (Figure 2) to help operators and maintainers troubleshoot pressure control problems.

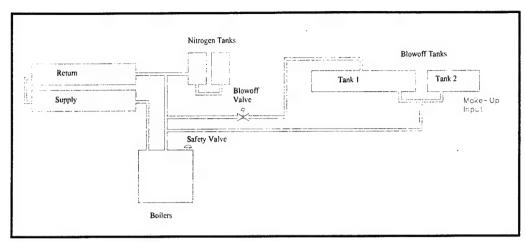
Figure 3. Plant 1240 HTHW system schematic.

The total volume HTHW distribution for Plant 1240 is 216,000 gal. There are five HTHW generators, three coal-fired units, and two gas/oil-fired units, as described in the December 1998 site visit. (Figure 3 shows a system schematic for Plant 1240.) The return temperature is typically about 350 °F at 425 psig. HTHW units are brought on line to best match the system load with the fewest number of units operating at maximum capacity. Additionally, before starting an on-coming HTHW unit, HTHW is circulated in the cold unit to heat the furnace surfaces. This reduces thermal stress and corrosion in the on-coming units. During such transitions (bringing units on- or offline), the distribution bulk temperature can vary causing the water volume to shrink or swell. Another type of event is the rapid loss of load due to a HTHW-to-steam converter being rapidly shutdown. This causes the bulk water temperature of the return and supply lines to increase, and causes the system volume to increase (i.e., to swell into the  $N_2$  tank).

Based on discussions with the operators, the team defined a large excursion as the return temperature jumping from 300 to 330 °F and the supply temperature jumping from 415 to 420 °F. This temperature change is due to the large thermal inertia of the HTHW distribution system. Note that, even though the HTHW-to-steam converters have ceased to draw energy from the supply lines, there is a large volume of water in route to meet the load. The energy in the supply line will move into the return side and greatly elevate the return temperature.

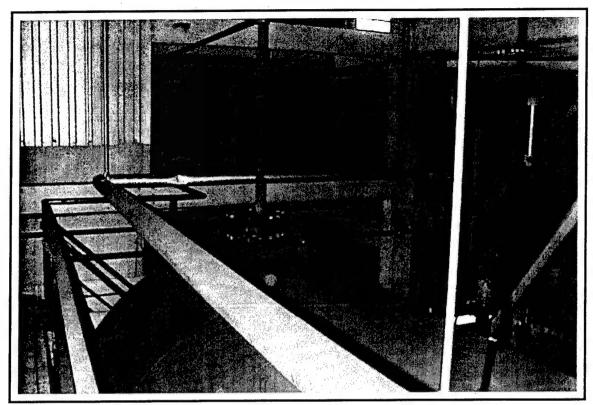
The current discharge piping arrangement (Figure 4) experiences large vibrations when discharging HTHW to the blowoff tank (Figure 5). When a transient necessitates discharge of HTHW, the blowoff valve (Figure 6) opens to release water at 350 °F and 440 psig to near ambient conditions. The pressure at the outlet of the valve will be slightly above ambient conditions due to flow resistance, but the increase in pressure will not be sufficient to prevent some of the HTHW from flashing to vapor. At 350 °F, steam occupies about 180 times more space than liquid water. Although only about 20 percent of the HTHW will flash to steam at atmospheric pressure, the acceleration of the two-phase mixture in the discharge pipe will cause severe water hammer.

Figure 4. HTHW blowoff piping.

Regardless of what solution WPAFB selects, the system needs to be modified to eliminate HTHW blowoff line water hammer. Additionally, the pipe anchoring needs to be corrected to allow for thermal expansion. The current bracing (Figure 10) seems to over-constrain the piping that was vibrating due to water hammer. The pipe needs to be allowed to expand along its length to prevent bowing in the pipe. This could be done with a three-sided rectangular piece of metal. The three-sided rectangular piece of metal should be as long as the pipe itself. The pipe should be placed between the two opposite sides of the piece of metal. The pipe should then be anchored with some u-bolts that will clamp the pipe to the piece of metal.

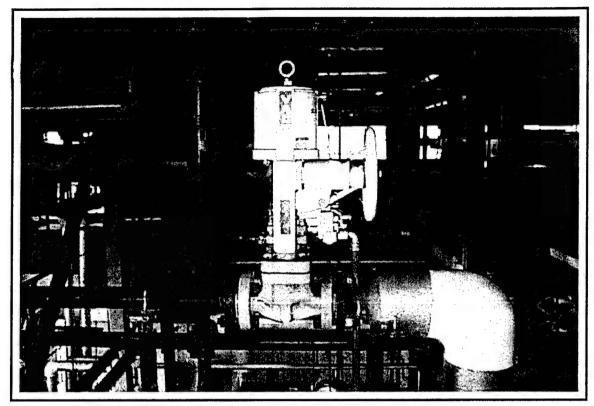
Figure 6. HTHW blowoff valve.

The team and plant staff concluded that the valve is not placed in the best position to minimize water hammer when discharging HTHW to the blowoff tanks. The team recommended that the blowoff valve would have the least water hammer when located to discharge into the top of the blowoff tank (Figure 8). This would eliminate two-phase flow in the discharge line from the blowoff valve to the blowoff tank.

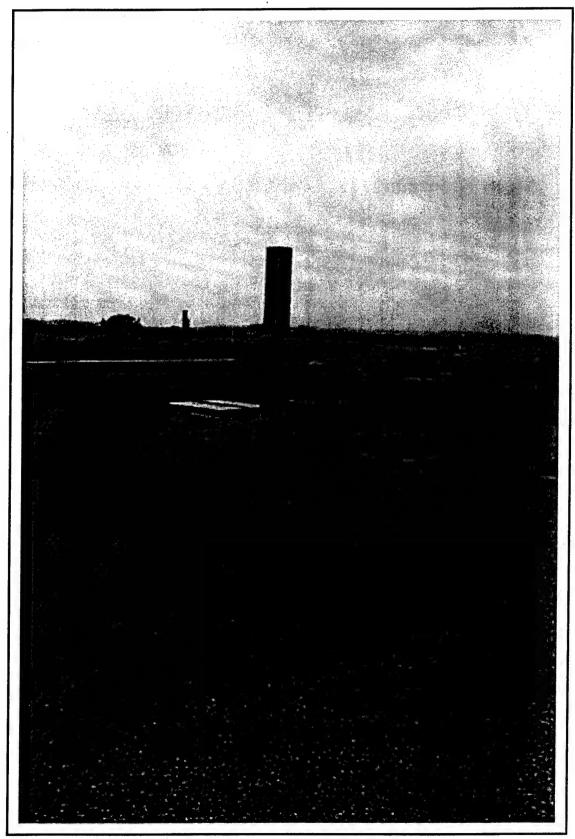
The plant staff was also concerned that the present location and size of the over-flow piping of the blowoff tank could cause damage to the plant roof. The steam created when the HTHW flashes into steam is vented out of the blowoff tank to the roof (Figure 7). The roof was inspected; currently there appears to be no damage to the plant roof. However, should there be prolonged venting, vent drains and piping should be installed to minimize exposing the flat roof to hot water and steam. If needed, SAI can provide drawings and specifications of typical vent drains.

Figure 7. Blowoff tank vent on the roof of Bldg 1240.

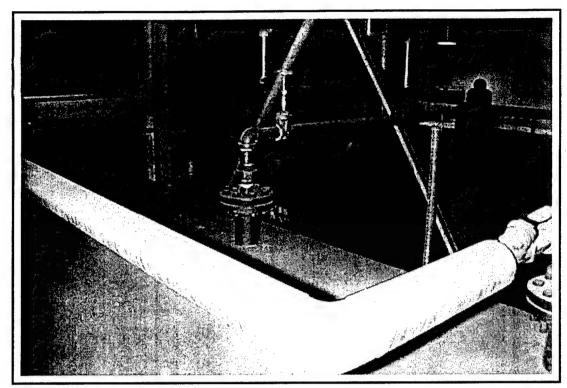
Figure 8. Top of blowoff tank.

The least costly solution would be to move the HTHW blowoff valve to the top of the blowoff tank. The discharge of the 1.5-in. valve would expand into an 8-in., schedule 80 pipe as it enters the expansion tank. The expansion will drastically reduce the flow velocity in the pipe. HTHW flashing to steam will still make noise, but some noise could be reduced by installing sound attenuating material around the blowoff valve area. Figure 9 shows the recommended configuration.

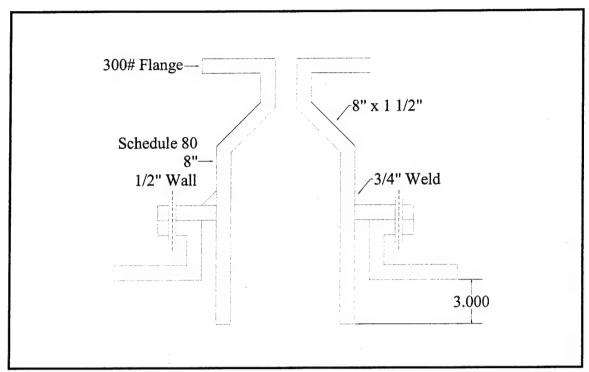
Figure 9. Blowoff valve modification.

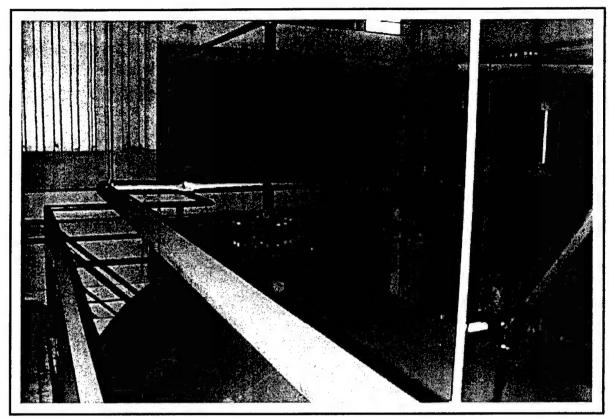
Figure 10. Current blowoff tank bracing.
